Subject : Meiners Oak Dam  
and Reservoir, No. 768  
Telephone Call

INSPECTION OF DAM AND RESERVOIR IN CERTIFIED STATUS

Name of dam Meiners Oaks Dam No. 768 County Ventura  
Type of dam earth Type of Spillway culvert  
Water is empty feet \_\_\_\_\_ spillway crest and \_\_\_\_\_ feet \_\_\_\_\_ dam crest.  
(above, below) (above, below)  
Contacts made Messrs. McWhirter and Wallbridge  
Detail in question Alteration to less than jurisdictional size  
Action taken See Remarks

MEINERS OAKS DAM, NO. 768  
EABelongie *EW* 3/23/73

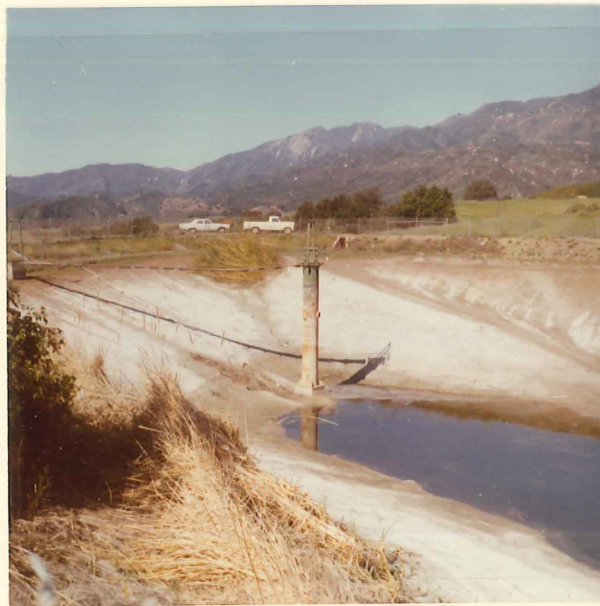
Outlet tower and culvert  
Spillway in background

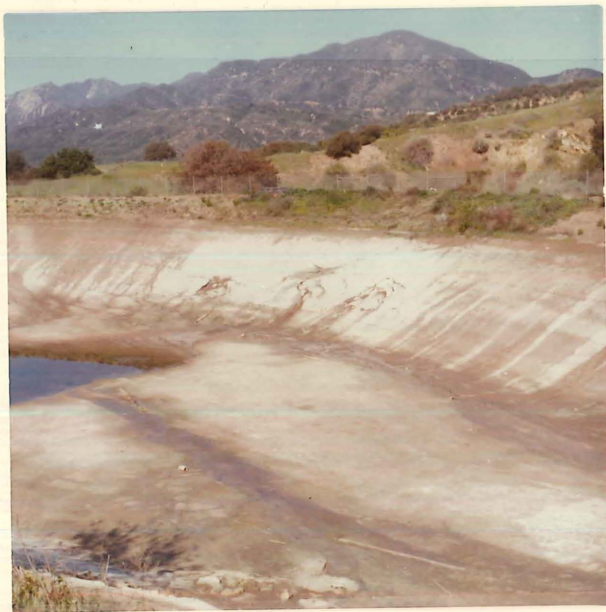
Sloughs on west side of reservoir

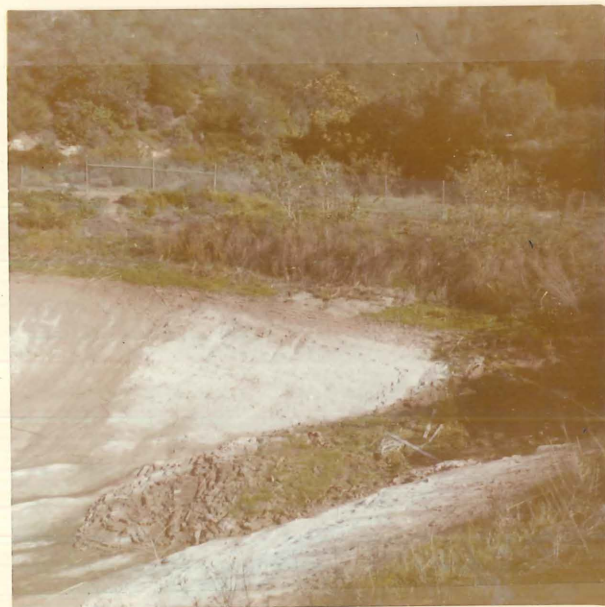
Embankment failure main canyon into reservoir

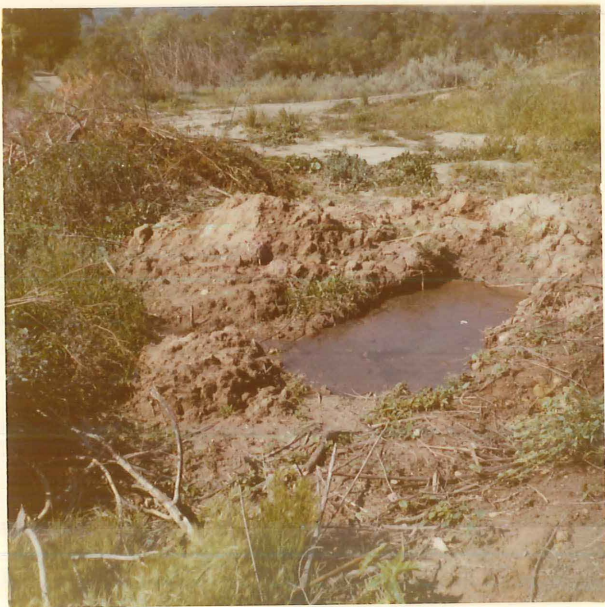
Leakage from break in inlet pipe

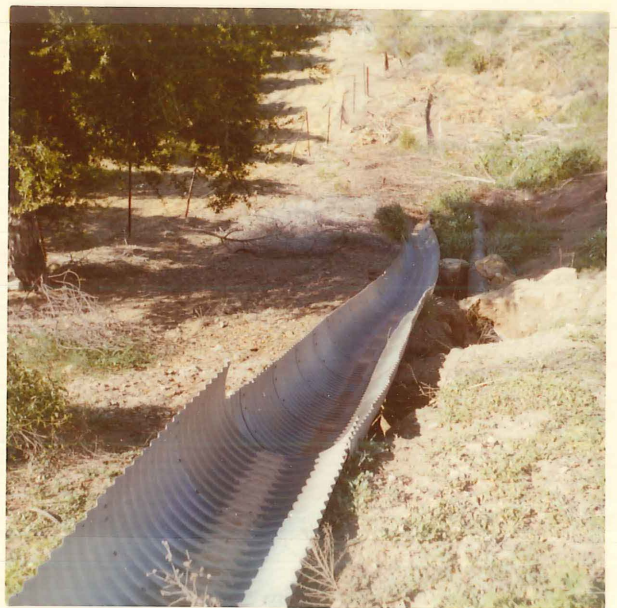
Erosion under left abutment ditch
