Memorandum of Special Postflood Inspections
January 27, 28, 29, and 31, 1969

MEINERS OAKS DAM, NO. 768
1/29/69 JJH

INSPECTION OF DAM AND RESERVOIR IN APPROVED STATUS

Name of dam Meiners Oaks Dam No. 768
Type of dam Earth Type of Spillway Concrete culvert
Water is 3 feet below spillway crest and _____ feet _____ dam crest.
(above, below) (above, below)
Contacts made Mr. Jackson of Meiners Oaks County Water District
Detail in question Periodic inspection
Action taken See "Remarks"

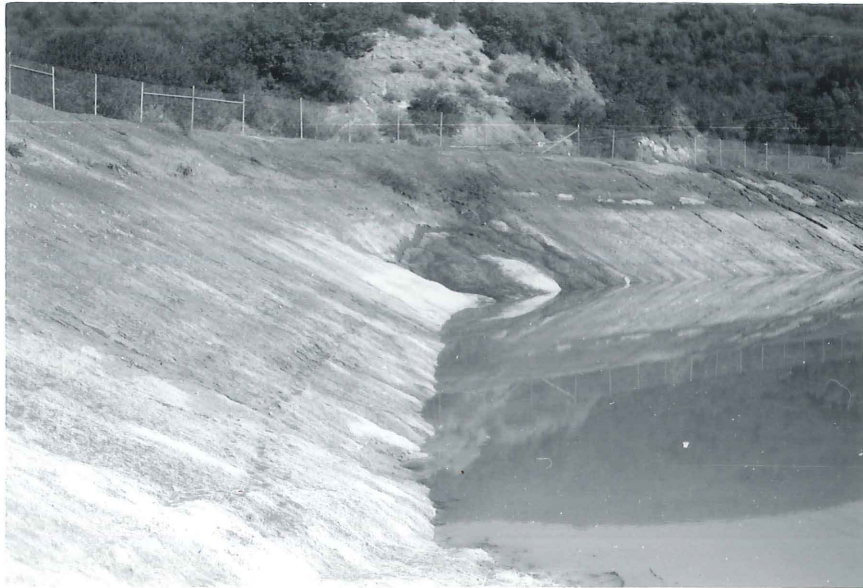
251.768

View of small shallow slide along
the northerly edge of the reservoir.

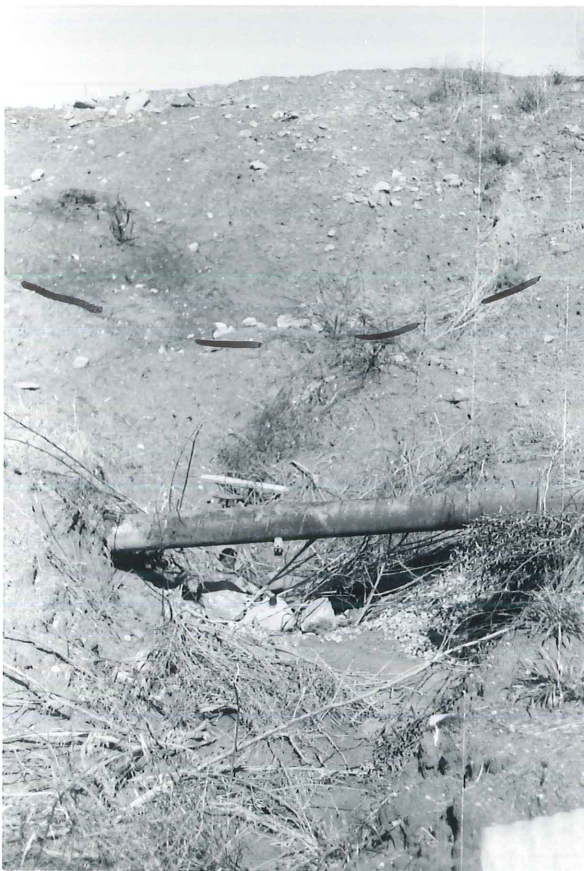
View, looking upstream from
toe of dam, showing depression
on the downstream slope.

A portion of the weed growth near the downstream toe had been removed to the point that an apparent shallow depression, located immediately upstream from the valve box at the downstream toe, was exposed. However, Mr. Jackson indicated that, after a break had occurred in the unencased section of the outlet pipe in 1958, a trench was excavated, repairs made, and additional encasement provided. Upon completion of the work, the area was filled in but apparently was not adequately recompacted or regraded, thus resulting in the irregular depression. Mr. J. E. Ley's field inspection of May 20, 1958, documents the additional encasement work, and therefore the reason for the remaining depression is plausible. During the inspection, no leakage was observed at the toe of the dam. Mr. Jackson is going to obtain a fire permit to allow burning of the remaining brush on the downstream slope.

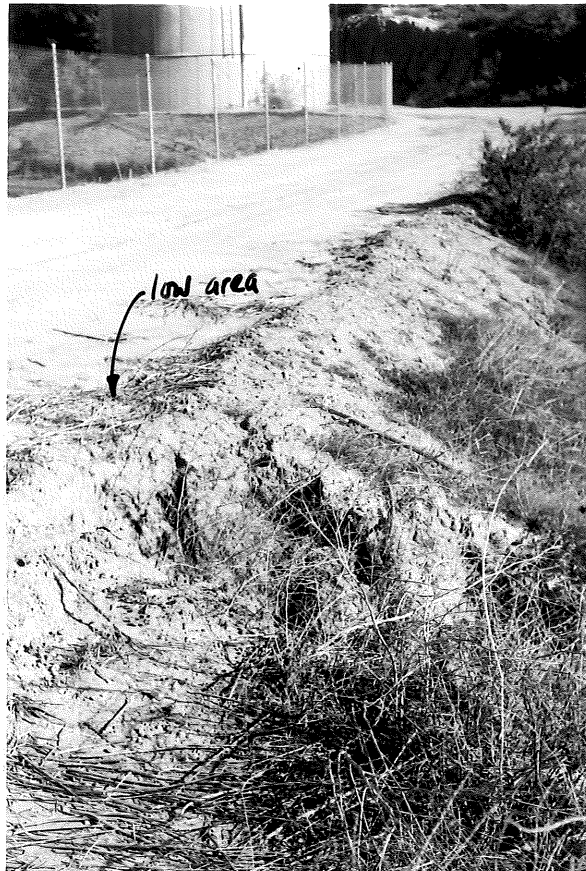
Meiners Oaks Dam, No. 768
1-10-67 J JH

An inspection of the dam crest revealed a low spot near the center of the dam and an erosion gully resulting from the recent rains on the downstream face. Mr. Jackson indicated that the low spot had existed there for some time. The as-built plans do not show any camber for the dam. It is possible that normal settlement of the dam has produced the low spot. However, it was noticed that the low spot is located approximately over the inlet-outlet pipe on a straight line between the tower and valve structure at the downstream toe. According to Mr. Jackson, this was the area of the crest used for dumping muck from the reservoir during cleaning, as documented in the inspection report of August 15, 1957, until we stopped the practice. The inspection report of August 15, 1957, indicates that the amount of dumped muck was enough to weight the upper portion of the downstream slope. It is possible that the low spot is the result. I instructed Mr. Jackson to take immediate measures to drain water away from the area to prevent further erosion of the downstream slope, and to watch the area closely. I believe that a line of survey monuments across the crest would be a valuable aid in detecting any detrimental settlement of the dam.

View shows area of low spot in crest and erosion gully on the downstream slope.

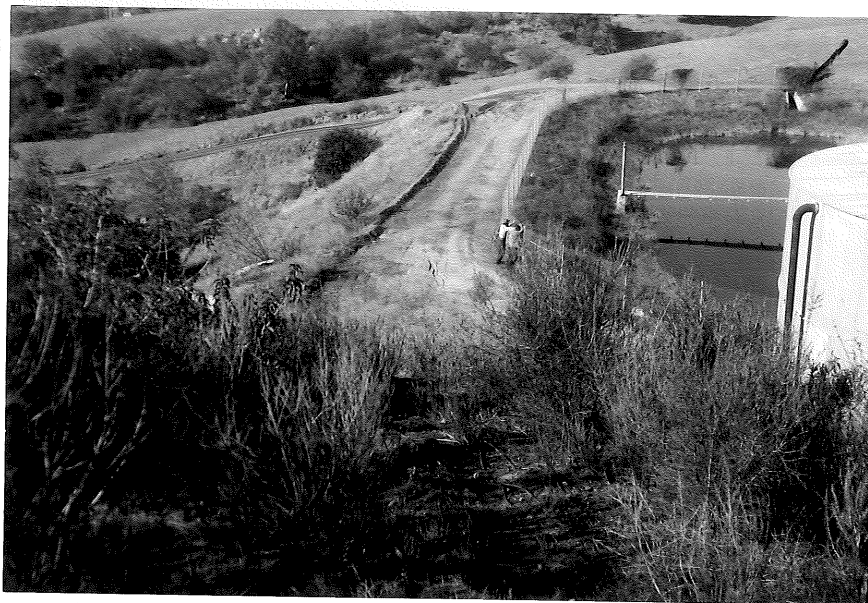
Meiners Oaks Dam No. 768
12-5-61 JEL

Looking across dam from left to right, spillway marked
by arrow.

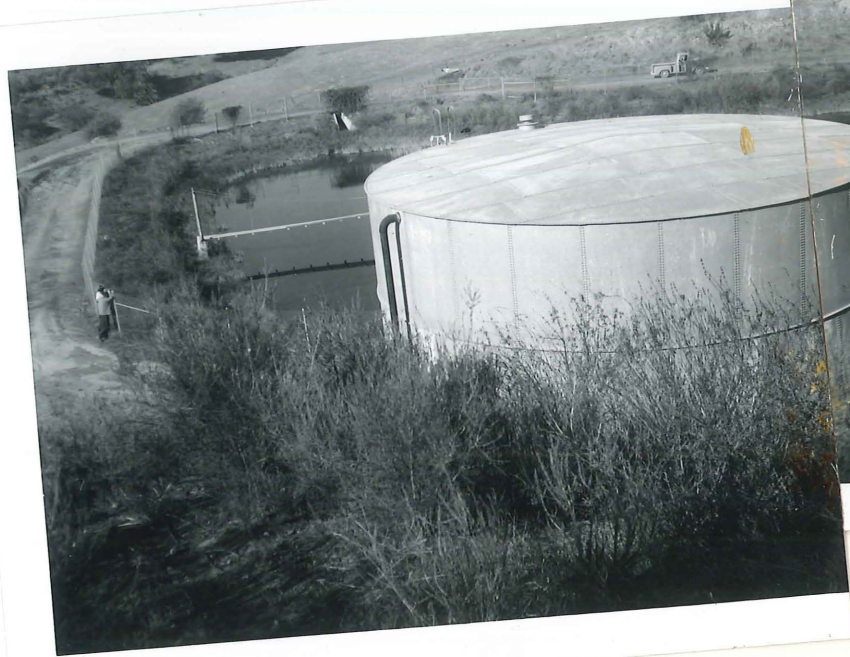
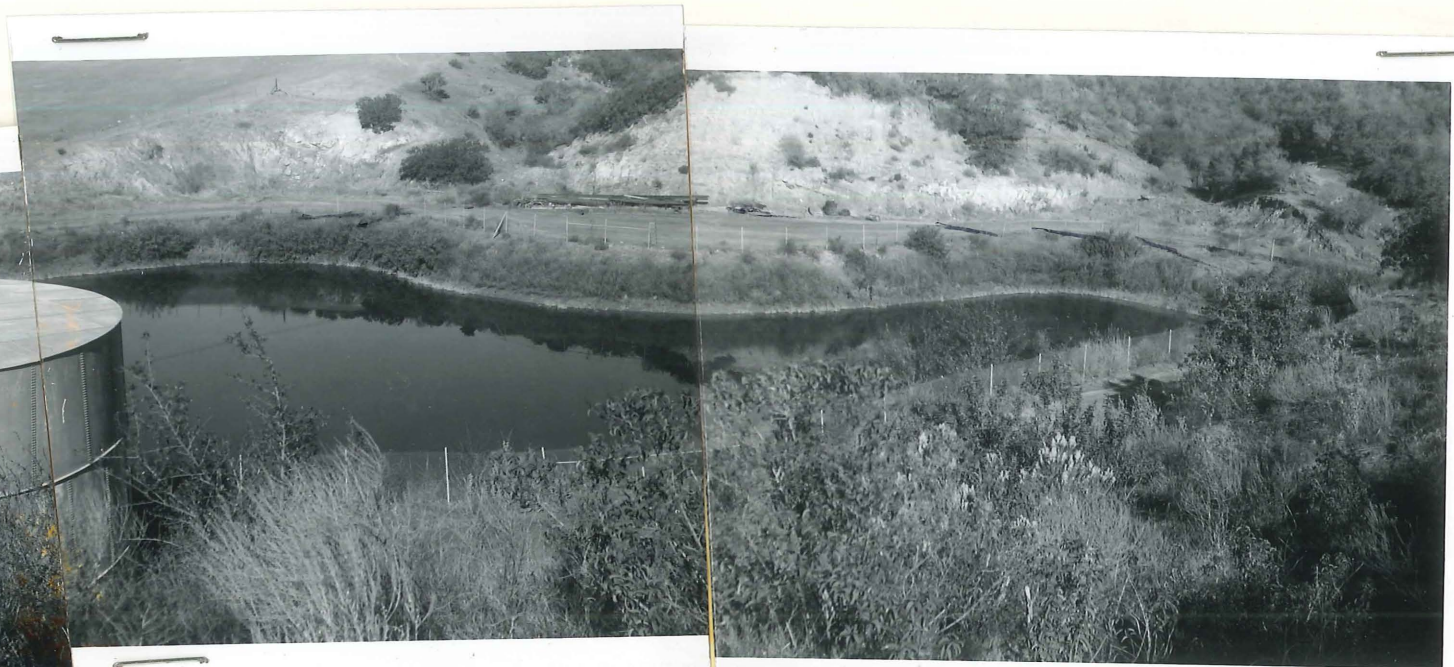
They intend to excavate a projecting area at the upstream right side of the reservoir. Removal of the material could increase the capacity from 6,000,000 to 7,000,000 gallons, according to Mr. Jackson. Removal of this material would have no effect on the dam. The excavated material would be hauled away. The writer asked that we be given the new capacity figure if the work is done. They will drain the reservoir in the near future for cleaning.

General view of reservoir from the left side; the area outlined by the dashed inked line is proposed for removal to increase storage capacity.

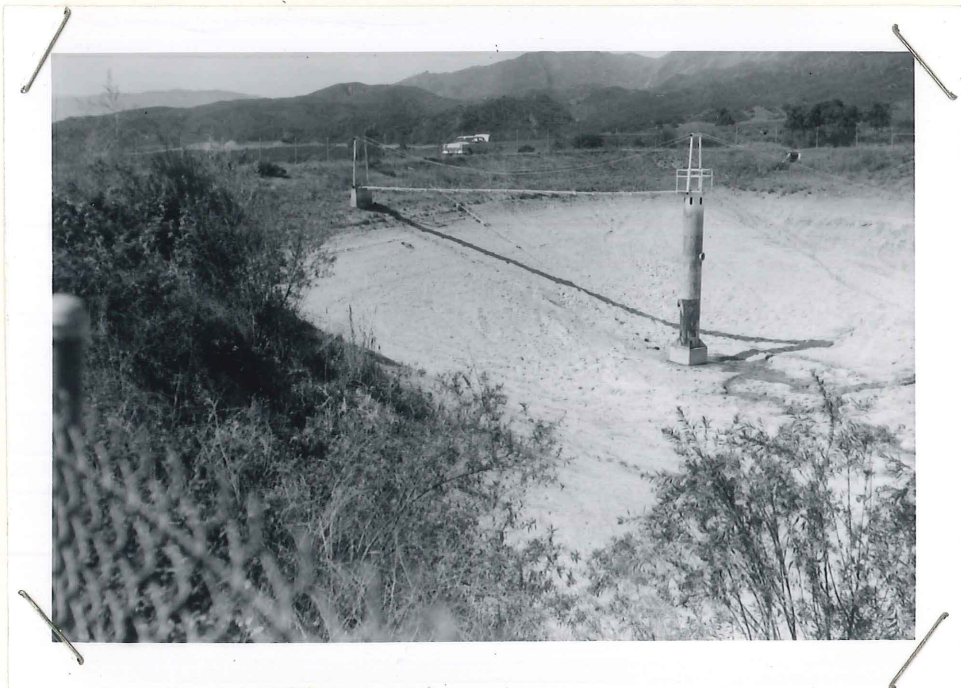
Meiners Oak Dam No. 768
3-11-59 JEL

Looking at upstream face from left side; note outlet tower;
arrow points to spillway.

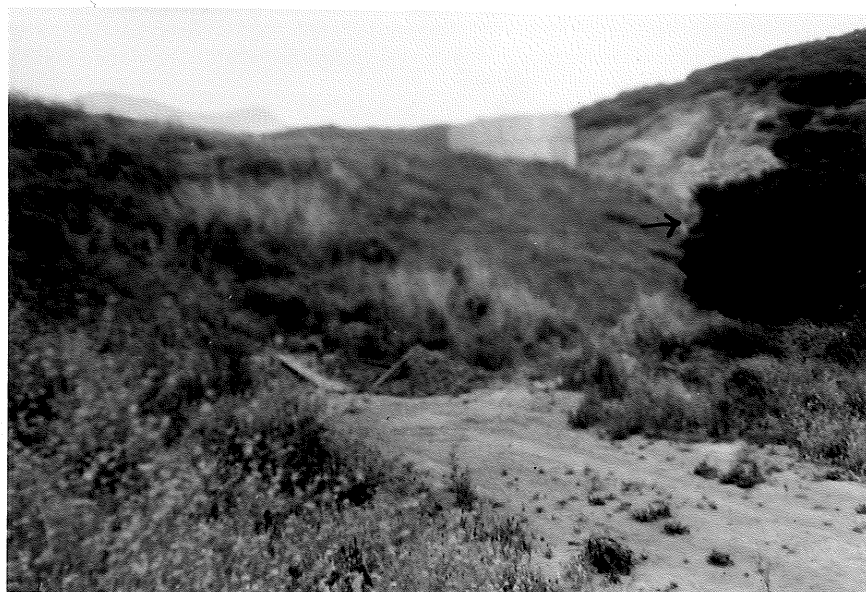
Miners Oaks Dam No. 768
5-20-58 J.E.L.

A steel tank has been built at the left side of the reservoir about 50 feet upstream of the dam, see picture, dated May 20, 1958. It sits next to the reservoir side slope on a foundation of medium hard sandstone. There were no signs of movement or settlement of the ground from the weight of this tank. A 12-inch discharge pipe from the tank is buried at the left abutment, then passes exposed down the left abutment contact. The maximum head on this pipe would be 24 feet. The pipe was buried bare. Mr. Jackson was told that we should have been informed before the installation of this tank. Installation of this tank could have been improved by: (1) Concrete encasement around the section of pipe that passes over the left abutment; (2) Moved back slightly farther from the top edge of the reservoir side slope.

Picture of downstream face, showing location of tank at left side of reservoir; arrow marks location of outlet line from tank.

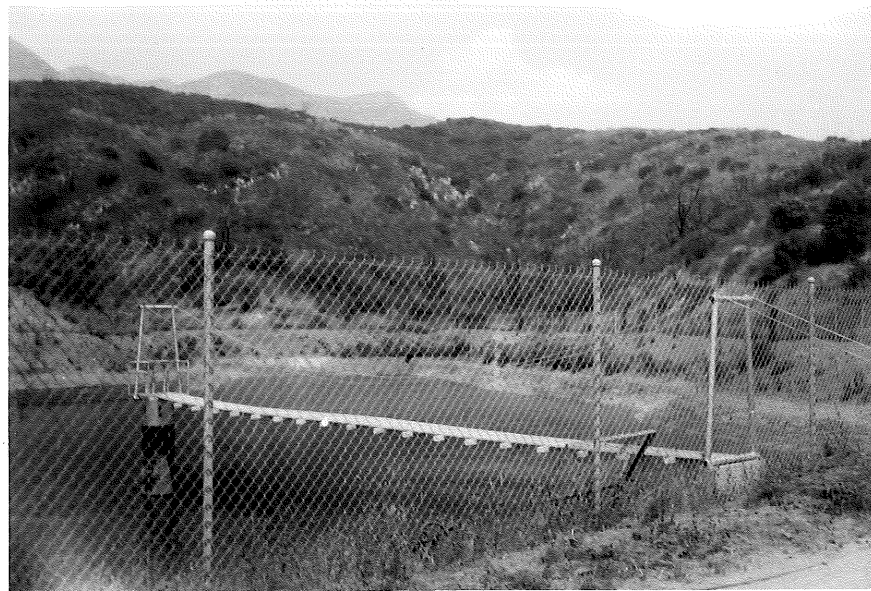
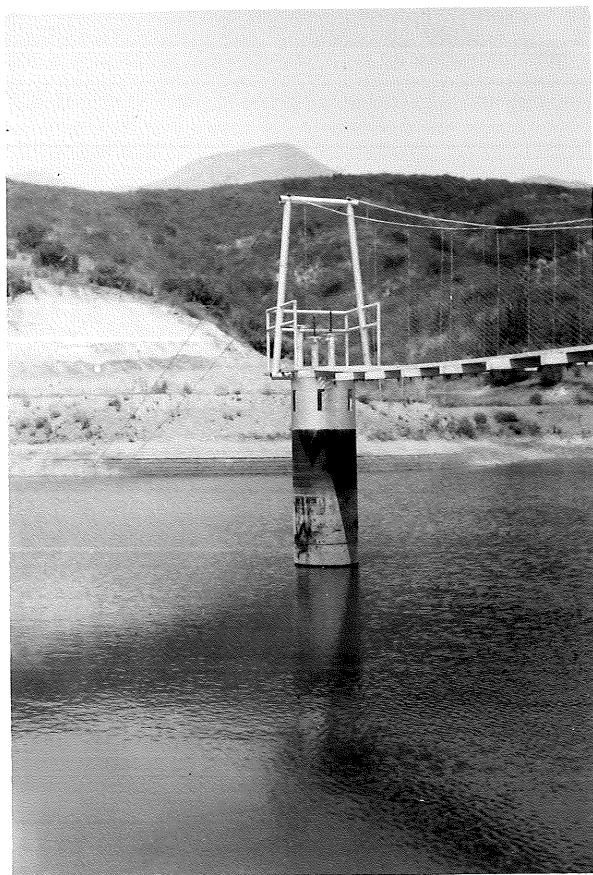
MEINERS OAKS DAM NO. 768
7-14-53 J.E.L.

Recently constructed
outlet tower.
