SUBJECT: Meiners Oaks Dam,
No. 768

Meiners Oaks Dam No. 768

Memo to Mr. W. H. Holmes
Meiner's Oaks Dam No. 768
Inspections of Construction
By J. V. Spielman

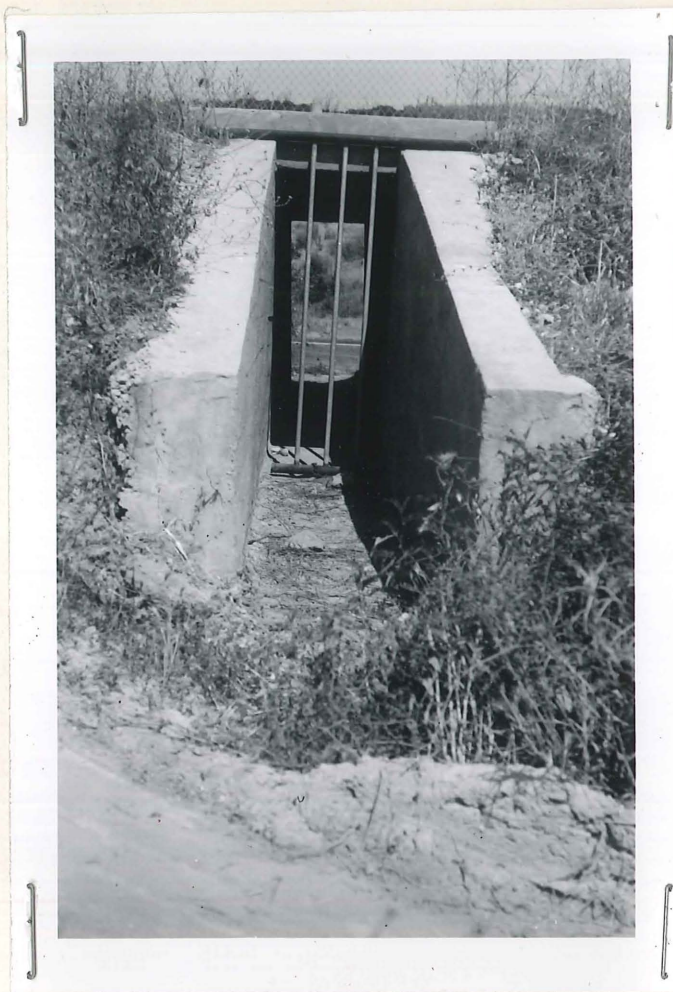
Picture looking upstream through
spillway showing grill over exit
portal.

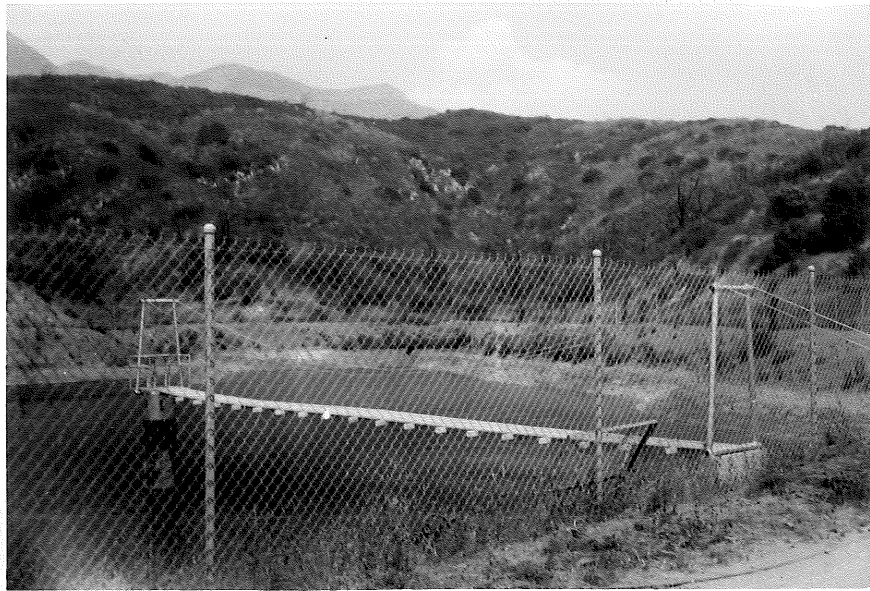
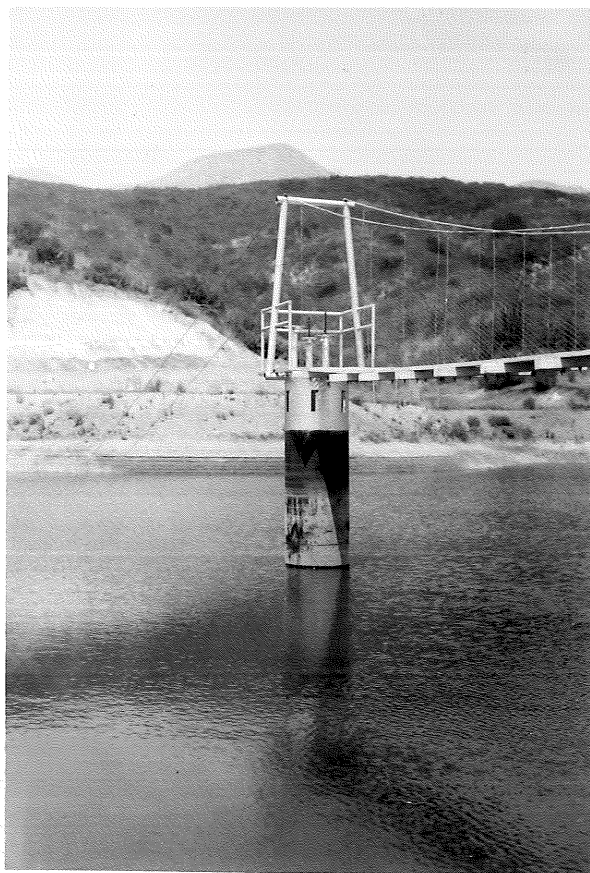
Meiners Oaks Dam No. 768
6-19-52 J.E.L.

Recently constructed
outlet tower.

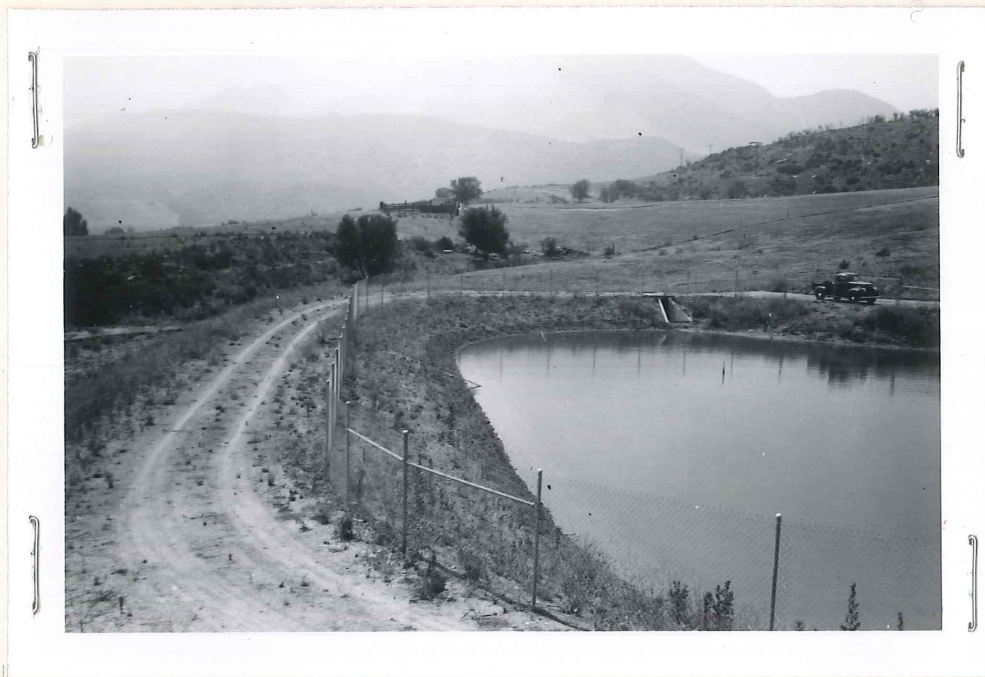
From left abutment

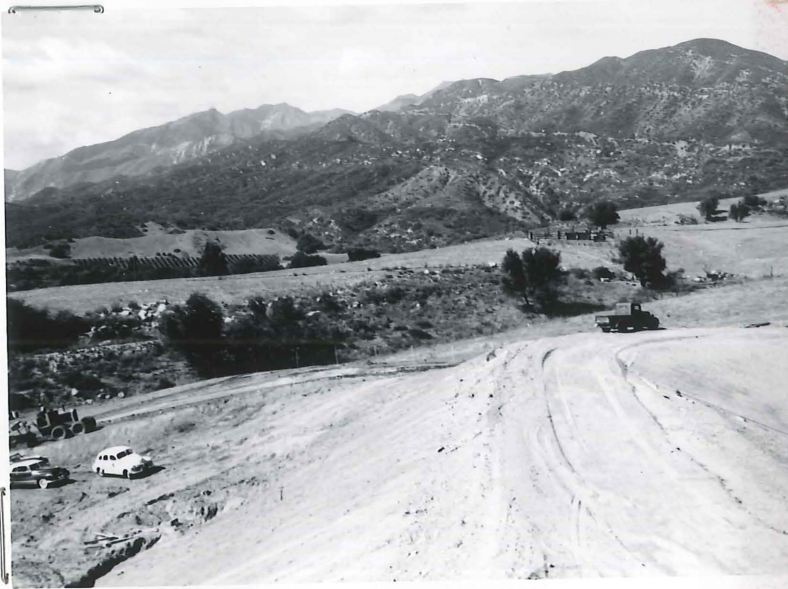
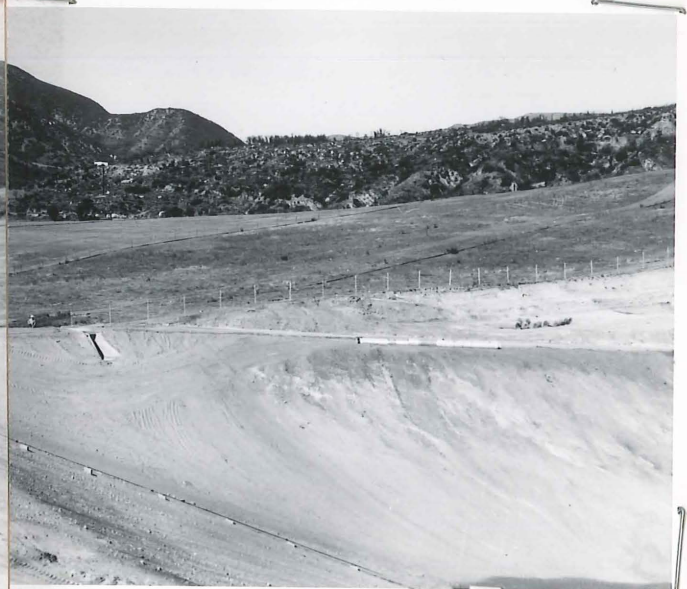
Completed embankment from left abutment.

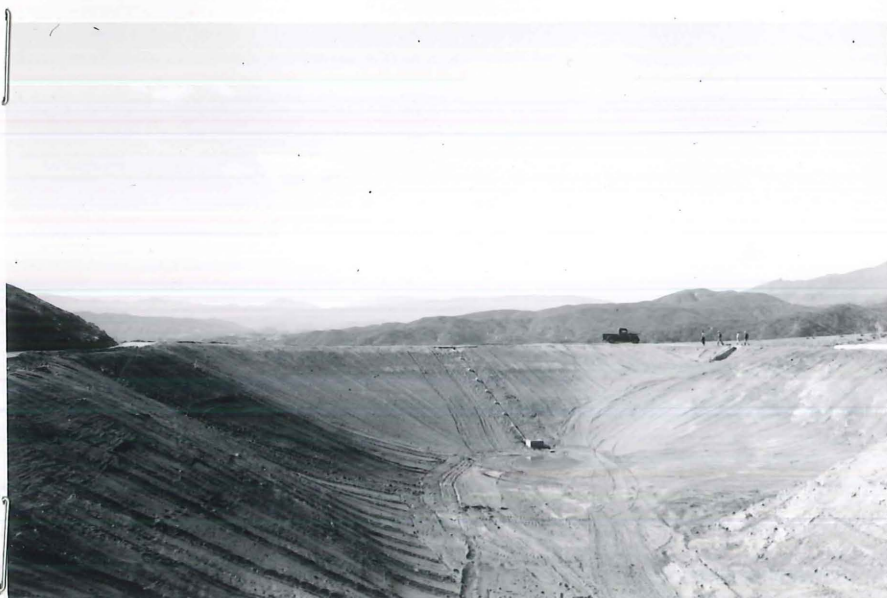
Upstream face of dam.

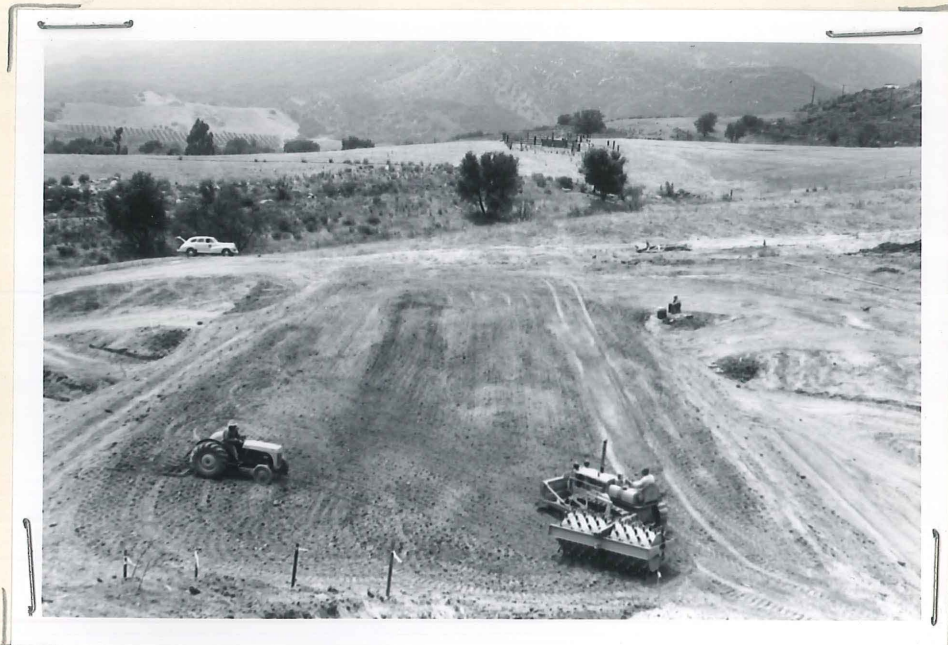
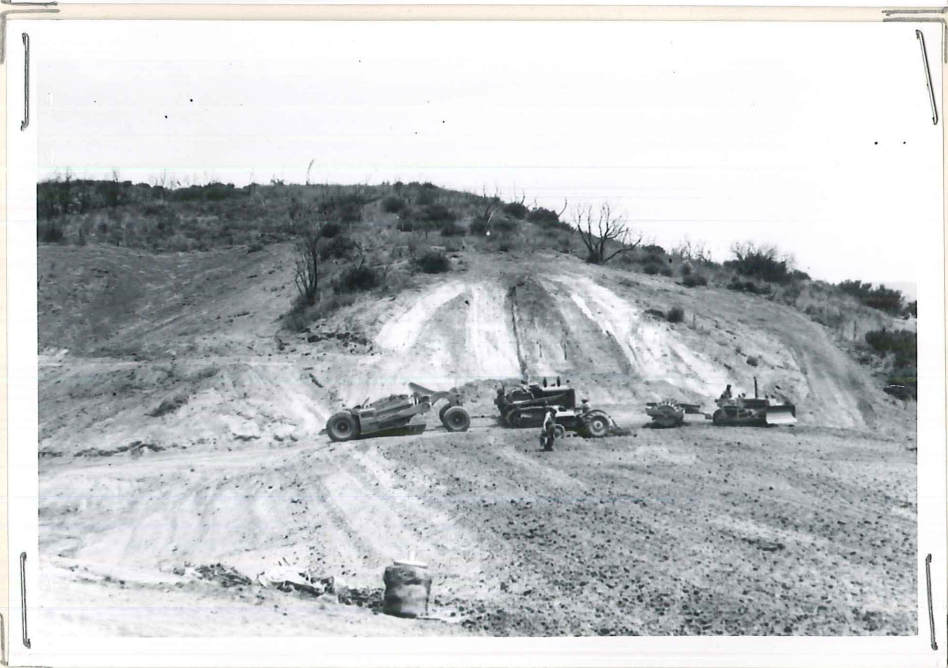
Views of embankment at elevation 896.

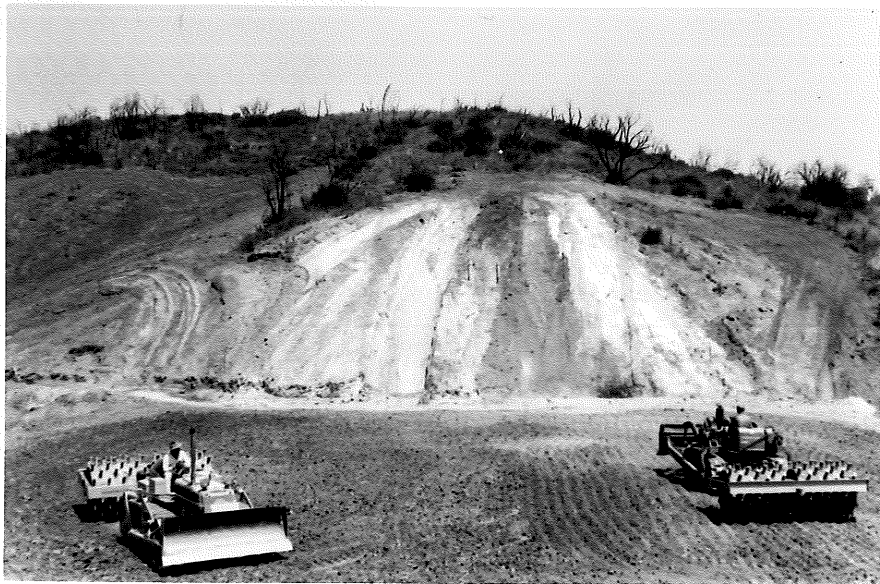
Looking towards left abutment which is very soft sandstone which breaks down easily and forms a pervious sandy zone along abutment.

Along the left abutment the formation is a soft yellow sandstone. The tractors easily break it down into a loose sand which would make a very short and pervious path for seepage along the abutment. This was called to the contractor's attention who tried to remove the loose sand with a dozer but of course a complete job cannot be done by this means. It was later called to Mr. Dron's attention that a pervious layer was being left along the abutment. It should be dug out by hand if necessary and compaction close to the soft sandstone had better be done by hand. This was all thoroughly discussed with Mr. Dron.

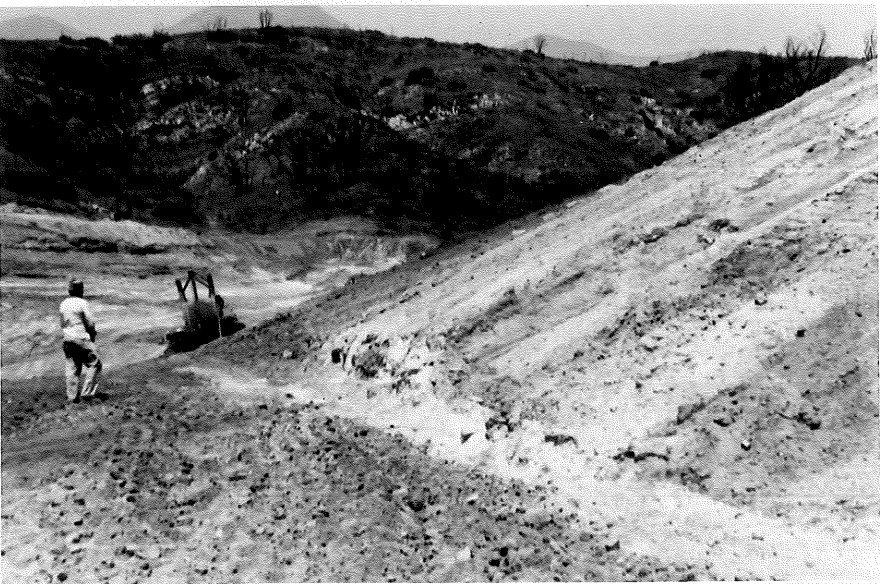
Closeup of sandy soil along left abutment which was later partly removed. (See Report).
