Earth Systems
Southern California

February 6, 2009

VT-24086-01
09-2-6

Project: Two Proposed Water Tanks
Meiners Oaks County Water District
Meiners Oaks Area of Ventura County, California

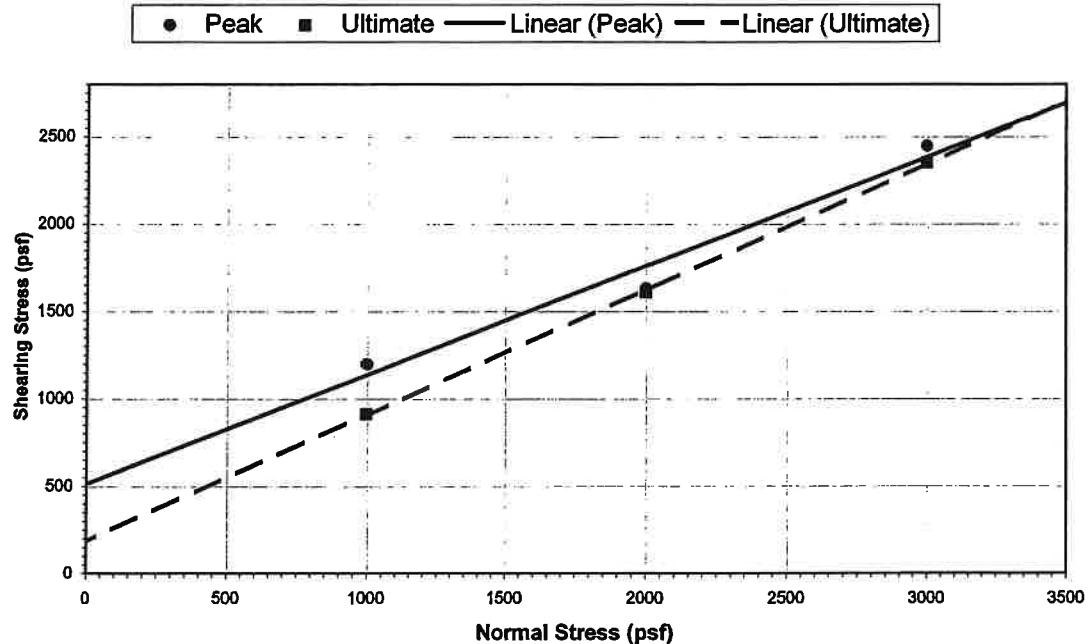
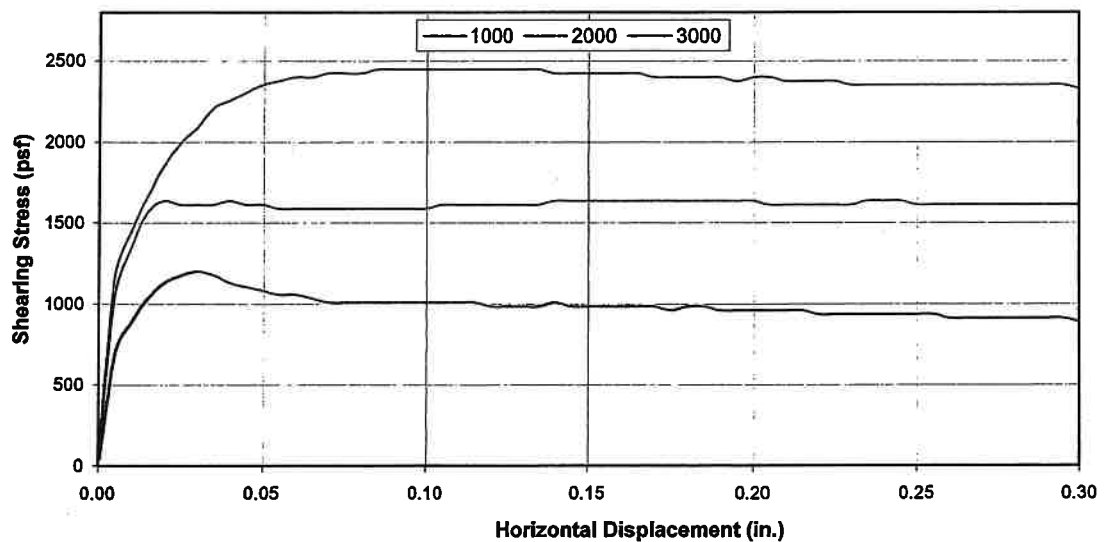
DIRECT SHEAR DATA*

Sample Location: T P 8 @ 0-5
 Sample Description: Gravelly Silty Sand
 Dry Density (pcf): 113.9
 Initial % Moisture: 9
 Average Degree of Saturation: 95.5
 Shear Rate (in/min): 0.0257 in/min

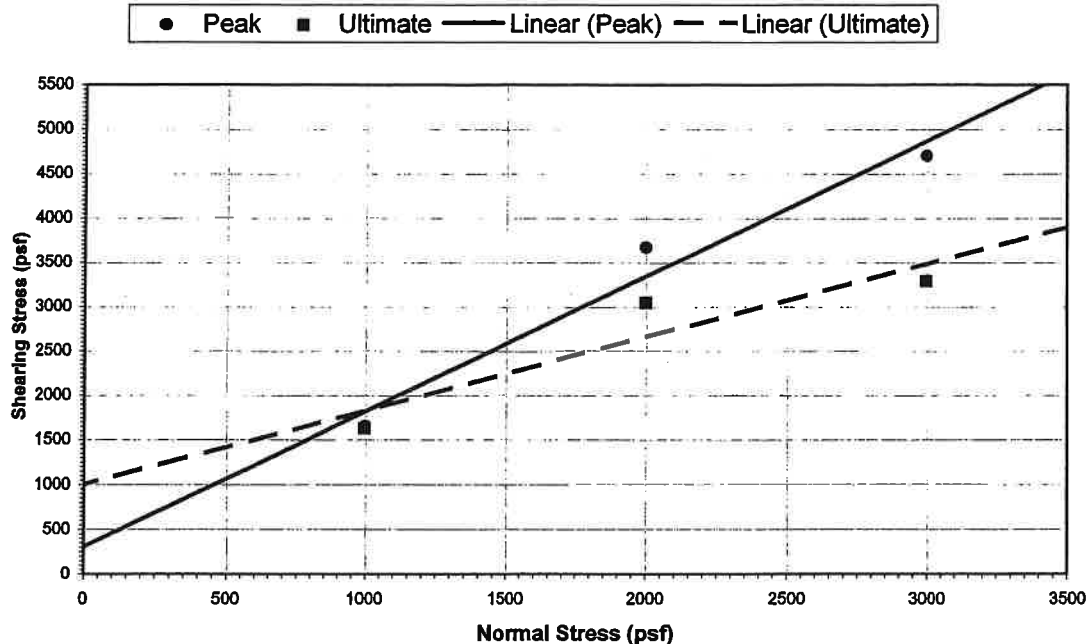
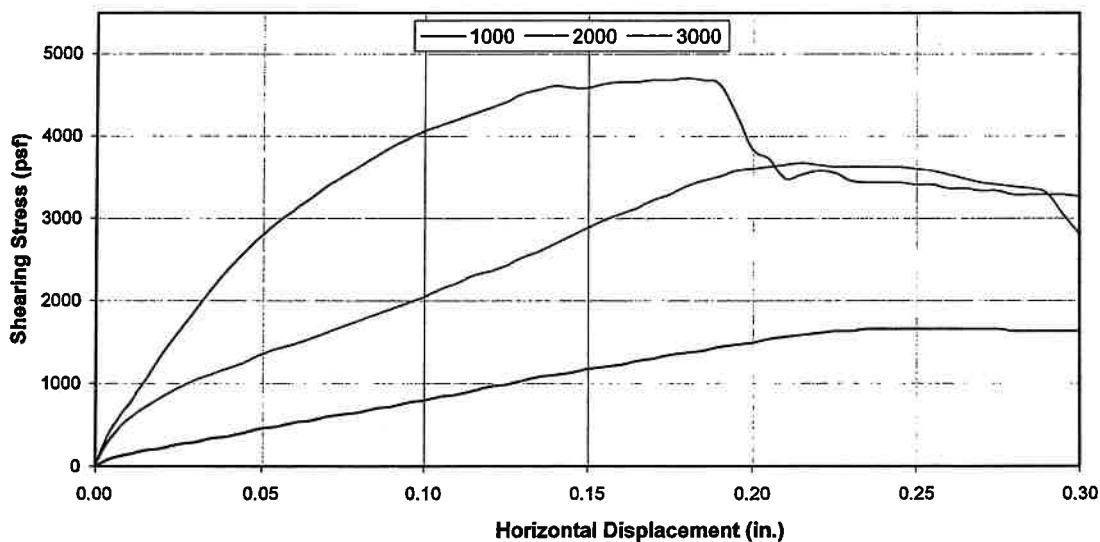
DIRECT SHEAR DATA*

Sample Location: T P 4 @ 4.5'
 Sample Description: Siltstone Sandstone
 Dry Density (pcf): 113.8
 Initial % Moisture: 8.9
 Average Degree of Saturation: 100.0
 Shear Rate (in/min): 0.0116 in/min

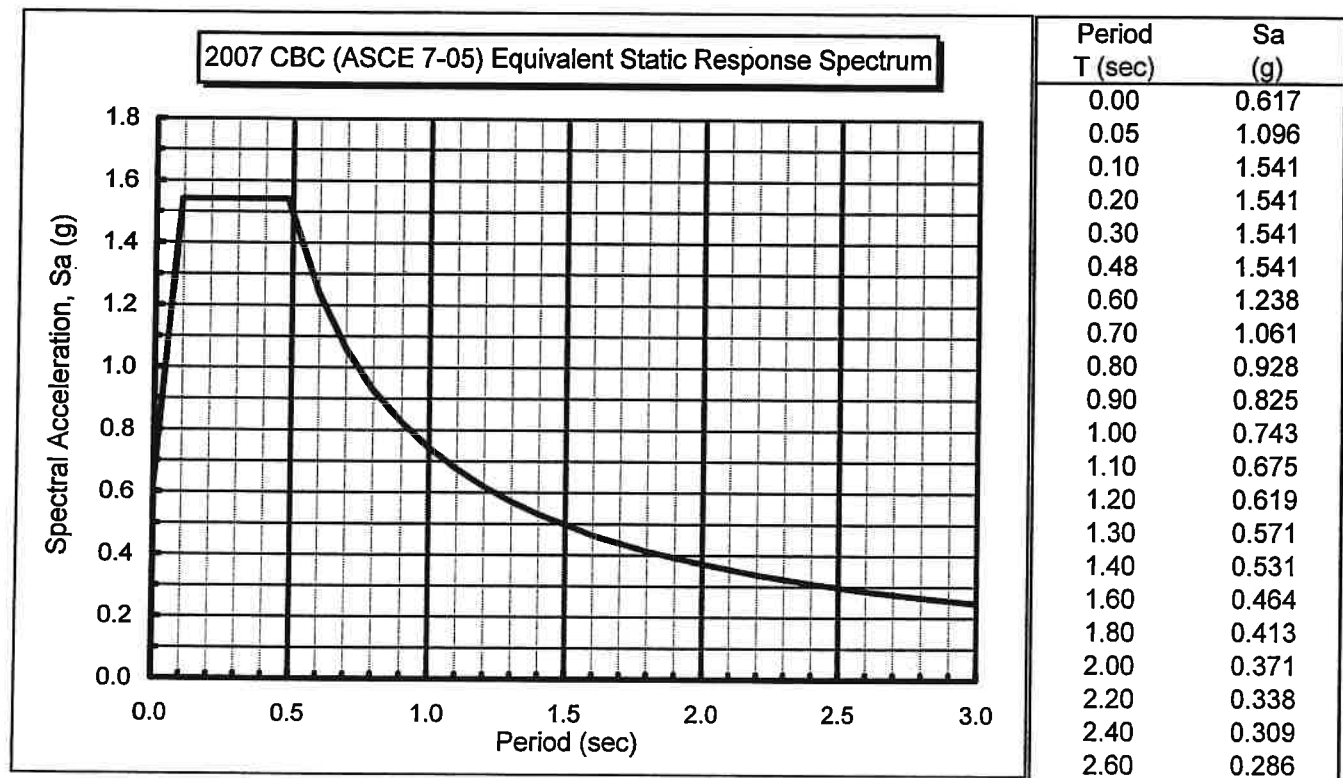
Design Earthquake Ground Motion

Short Period Spectral Response	S_{DS}	1.541 g	$= 2/3 * S_{MS}$	
1 second Spectral Response	S_{D1}	0.743 g	$= 2/3 * S_{M1}$	
	T_o	0.10 sec	$= 0.2 * S_{D1} / S_{DS}$	
	T_s	0.48 sec	$= S_{D1} / S_{DS}$

The 2007 CBC requires design by different seismic parameters than required by the previous building code. The site is located at about geographic coordinates 34.4627N and 119.27570W. These values were input into the USGS's web based Seismic Hazard Curves and Uniform Response Spectra calculator to determine the site's short term (0.2 sec.) and long term (1.0 sec.)
